Queensland Vintage and Warplane News

Vol. 17/03

A Queensland Vintage Aeroplane Group – Australian Flying Museum Inc.
Publication

Tech Notes on Wood used in Aircraft Construction

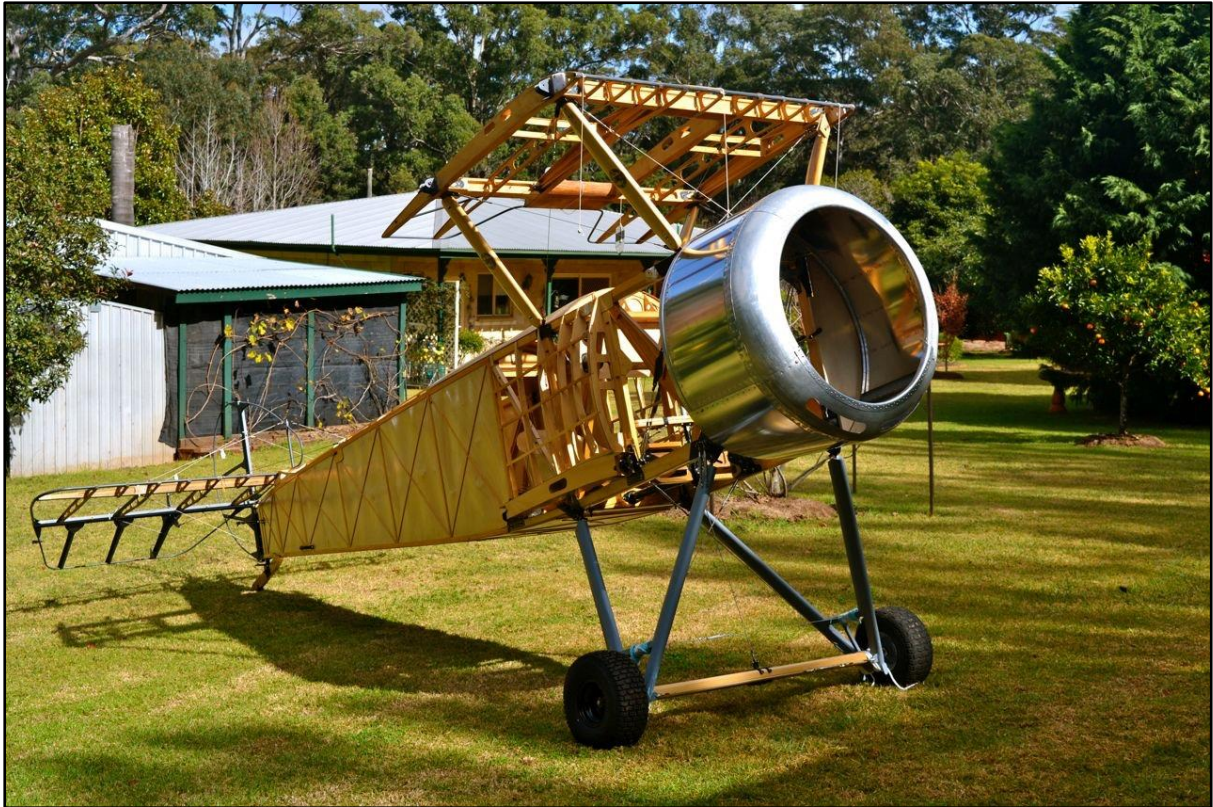
Member Paddy Martin reports that work on his Sopwith Pup is progressing well. The photo above shows just what is involved in building a WW1 replica. We will be doing a detailed article on Paddy's replica aeroplane in a future edition of this journal.

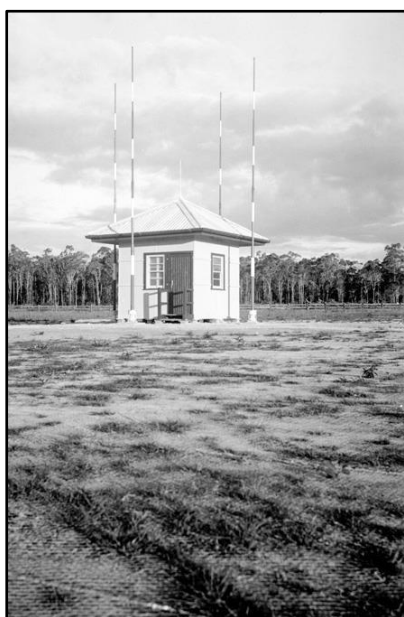
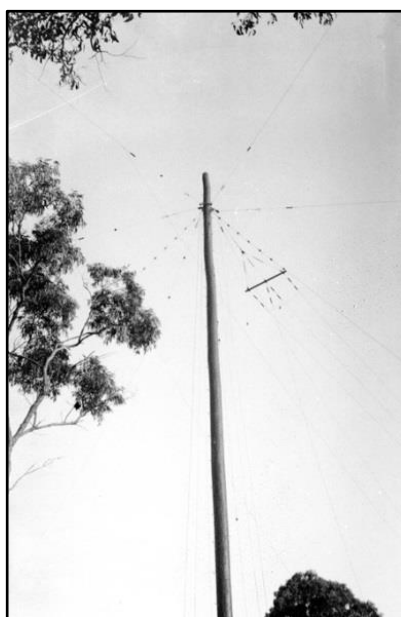
Two of the photographs on this page of the HF transmitting station and part of its antenna system installed at Bundaberg.

The photograph on the bottom left is of the Adcock-type HF/DF (High Frequency/Direction Finding) station installed at RAAF Station Bundaberg.

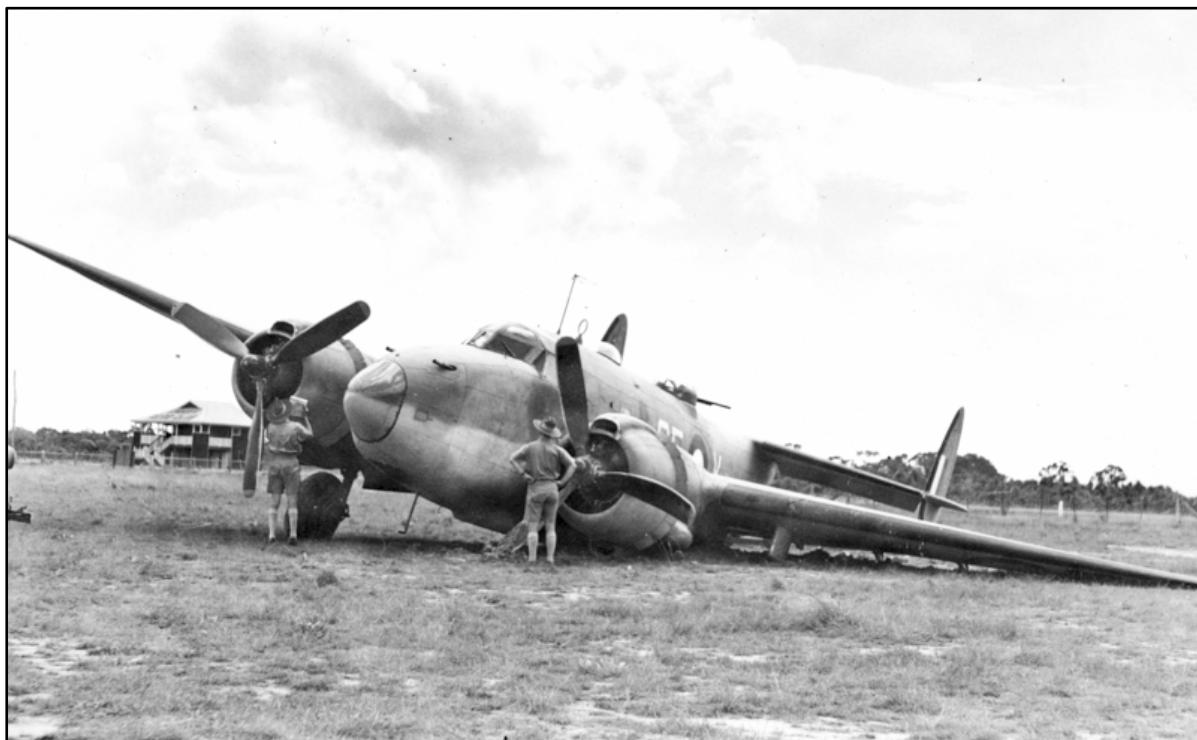
Image above: RAAF Ventura A59-51 that had an undercarriage collapse whilst landing at Bundaberg.

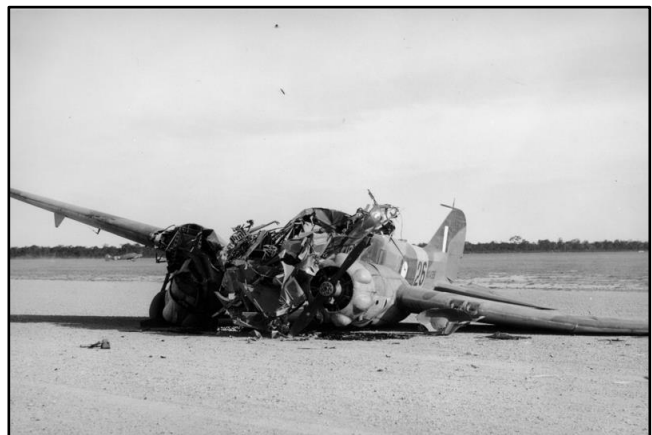
Image above: RAAF Anson AX439 aeroplane after head on collision with a RAAF Beaufort aeroplane A9-276

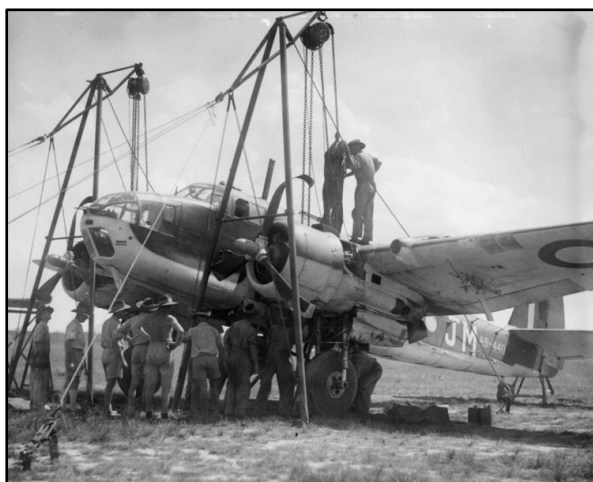
Photo above: RAAF Beaufort A9-440 being recovered after a wheel up landing
